ENGINEERING EVALUATION OF THE  
CHEMICAL AND BIOLOGICAL MODIFICATION  
KIT FOR EXISTING FIELD STRUCTURES

This test, Project 3762W004, was responsive to an Air Force Armament Laboratory (AFATL) letter, dated 1 August 1968, subject: "Test Request for CB Mod Kit for Structures." Testing was conducted from 9 December 1968 to 15 April 1969.

#### ABSTRACT

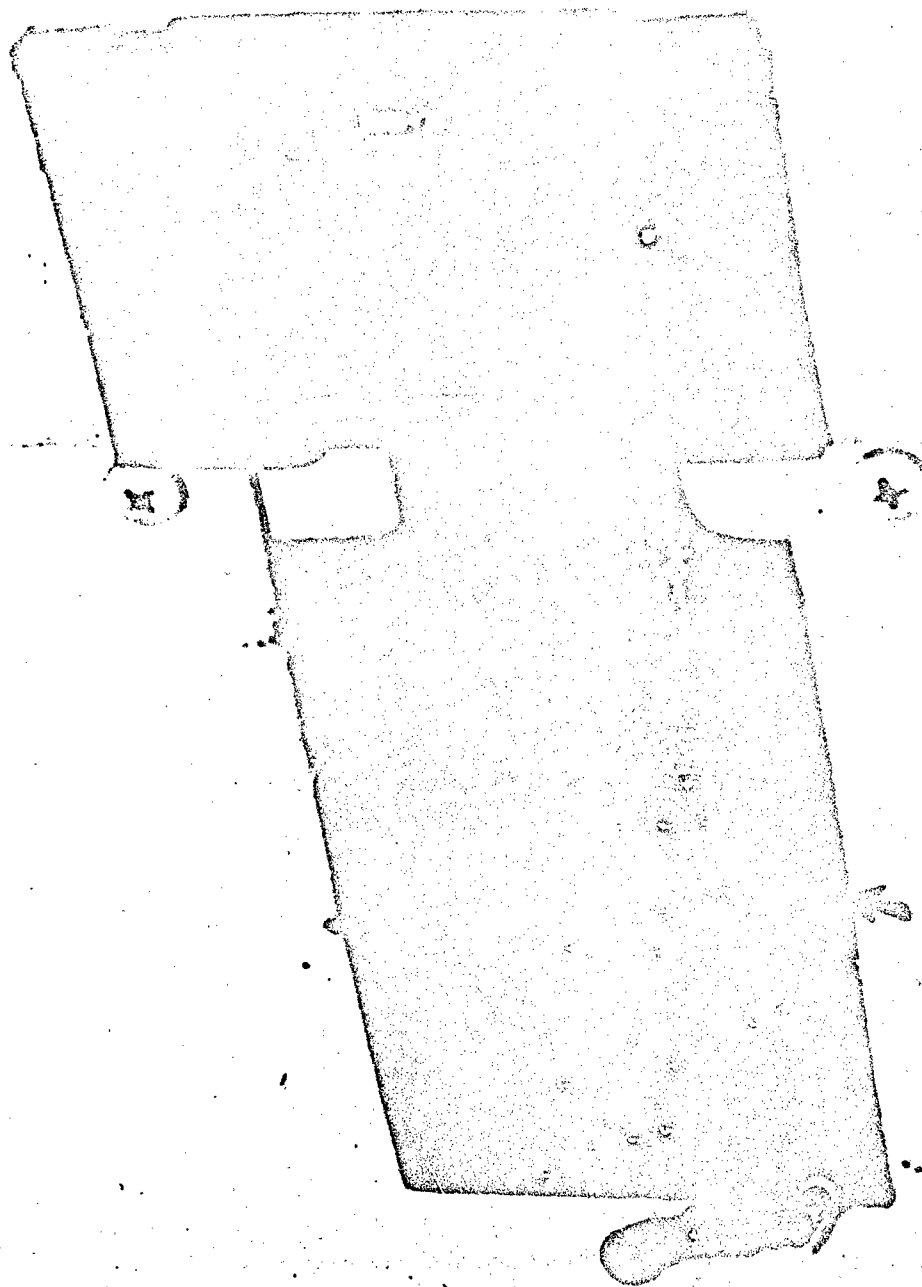
**HUMIDITY TEST.** The humidity test severely degraded the modification kit. Although all fittings were military specification items, uncoated steel screws, latches, and fittings were severely corroded. Those fittings which had a chromate dip were unaffected. The plunger-type door releases on the inside of the outer airlock doors had to be broken loose with a hammer before they would function (Figure 9). The switches on the door jams of the outer airlock doors, which control the dampers, were frozen. This means that the modification kit would lose overpressure whenever an airlock door was opened. This switch also controls the WAIT-ENTER lights in the entrance airlock. The floor in the shower was buckled upward so that the side panels could not be opened, precluding use of the shower (Figure 10). The interior airlock doors had swollen and were cracked. Air heater control relays located in the electrical control panel were corroded (Figure 11). The gasket on the front box containing the control panel was loose. The floor in the plenum chamber was buckled slightly so that the perforated door could not be opened (Figure 12). Further inspection revealed that the swelling and buckling were due to expansion of the polyurethane foam insulation (Figure 13 and 14). Rust on the ceiling had blistered (Figure 15).

Figure 13. Polyurethane foam swelled from humidity test
